**BUILDING  
SCIENCE  
SERIES**

**25**

# Structural Performance Evaluation Of a Building System

Edward O. Pfrang and Felix Y. Yokel

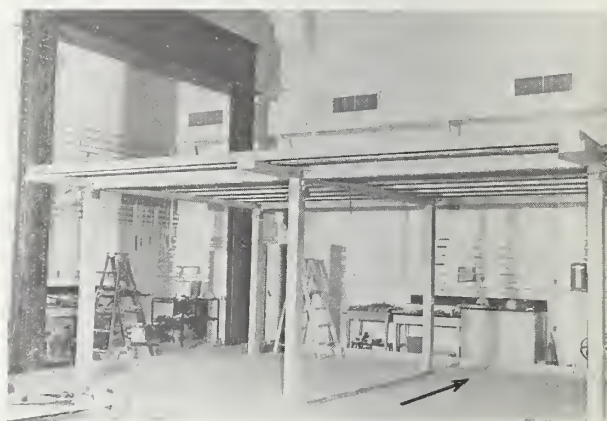
FIGURE 5.24. Test structure before the installation of walls.

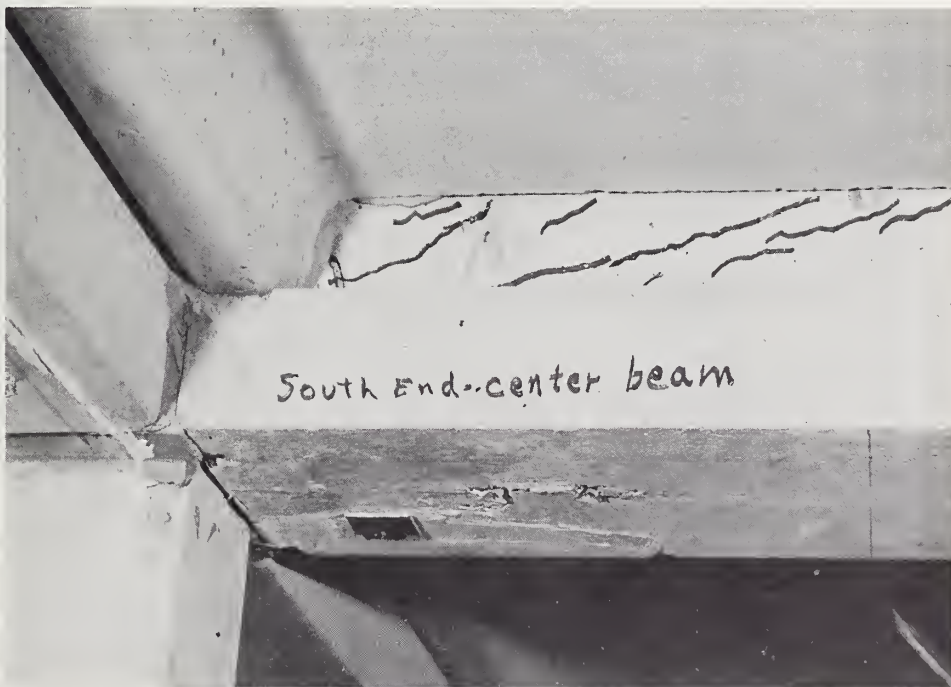
FIGURE 9.3. Diagonal tension cracking at  $w = 270$  psf (Test No. 16).
